Damage characterization of surface and sub-surface defects in stitch-bonded biaxial carbon/epoxy composites

Masoud Yekani Fard^{a,*}, Seid Mohammadali Sadat^a, Brian B. Raji^b, Aditi Chattopadhyay^a

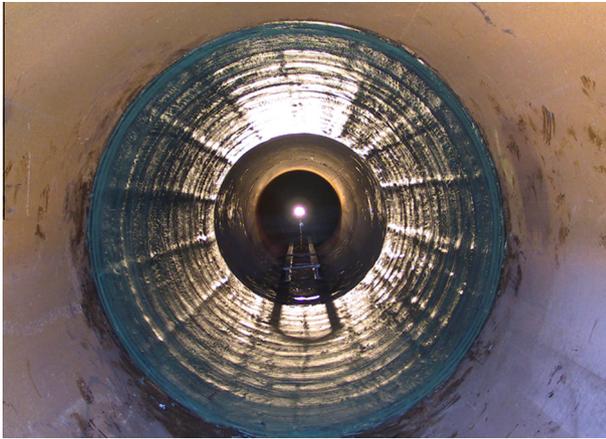
Fig. 1. Carbon fiber composite repair of 3m pipe underground.
